Elimination Of ESD Defects using DICO2

John Halladay¹, Barbara Teeter²,
Robert Newcomb³, William Usry³,
JooHwan Yoo¹, Kinsang Lam¹,
Jeremy Lansford¹, and Bill Brennan¹

¹Spancion Fab 25, Austin TX 78741

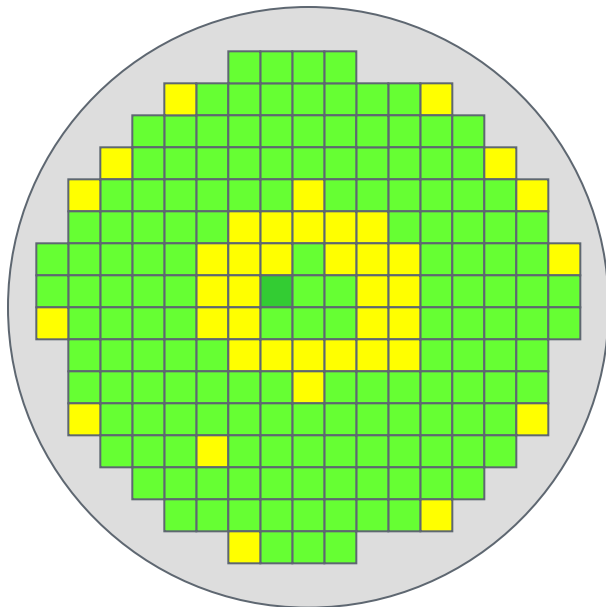
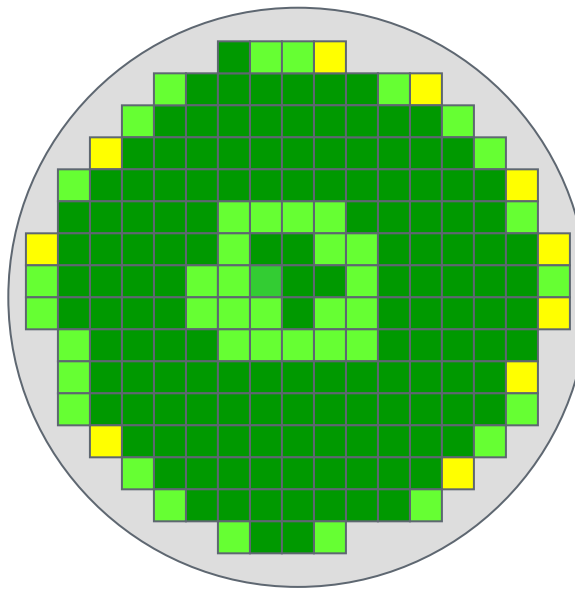
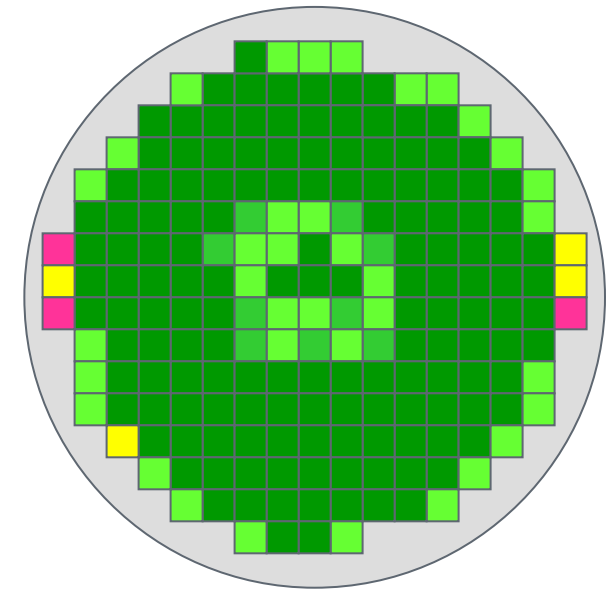
-Stacked wafer maps (~100 wafers) identify center donut region with reduced yield

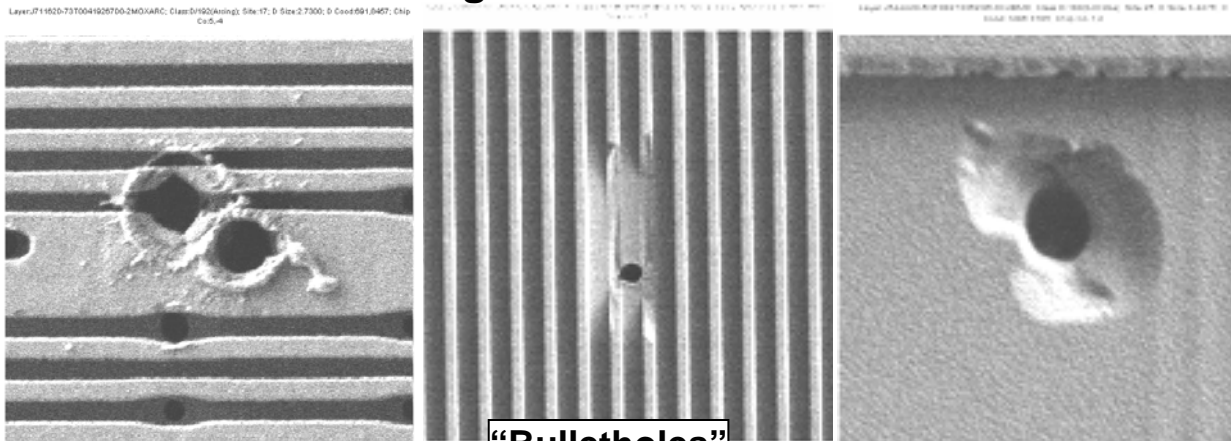
Defect Images Post- Trench Etch

- A Defect-to-Sort correlation on defective die in the donut region identified defects that correlate with specific SORT bin failures
- This defect type is found/observed in the center of the wafer and not out near the edge, consistent with the SORT signal
- The defect morphology is consistent with micro-arcng, typically from the trench etch process
- Significant effort invested in trench etch recipe modifications to quantify and reduce arcing without positive effect

“Bulletholes”

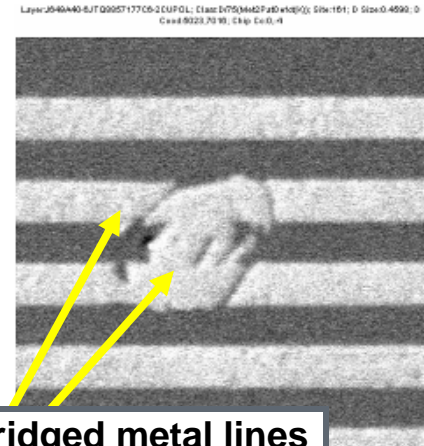
Post- Cu Polish

Bridged metal lines

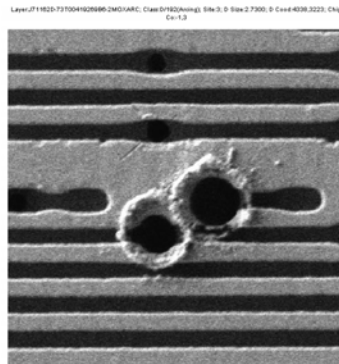
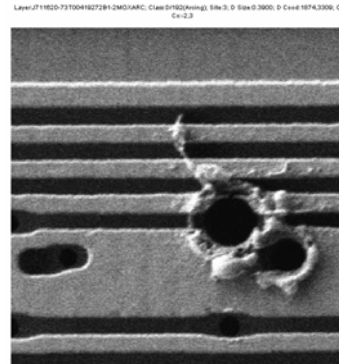
Pre WS

No defect present in pre-scan

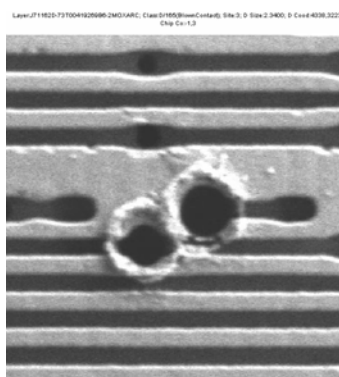
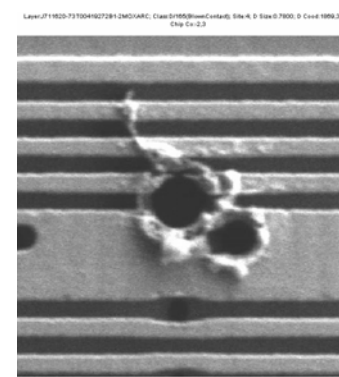
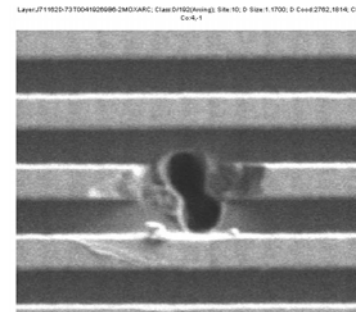
Post WS

- Arc defects prior to WS indicates arcing occurs in Trench Etch process
- One arc defect detected post-WS, not detected in pre-WS scan
 - A new defect or one missed by pre-scan?

New Defect?

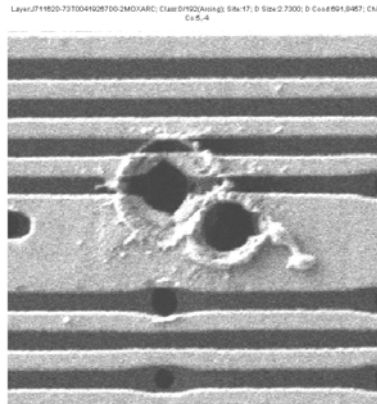
Typical Etcher Defect

- Frequently 'double strike'
- Ring of material around hole
- Melted appearance

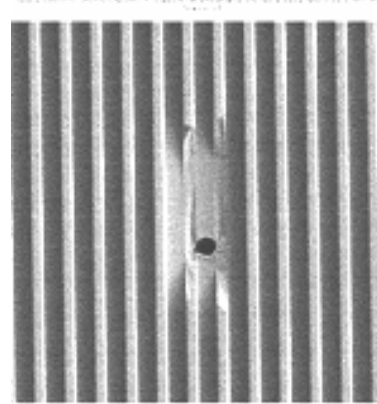
Typical WS Defect

- Always single site
- Oxide missing/sheared
- Very clean, no slag

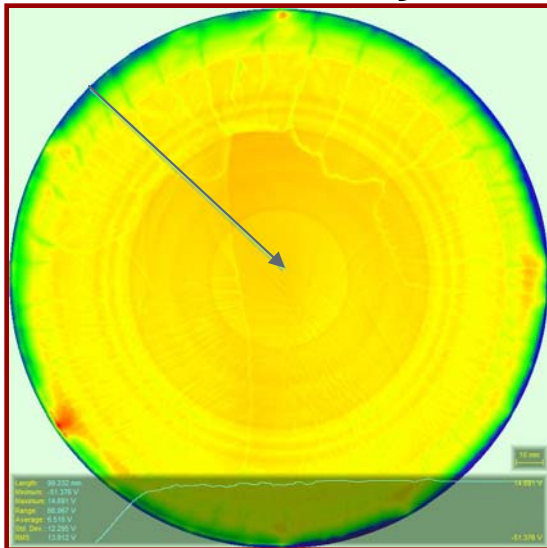
DI/N2 only

**min = -11.2 V max 3.0 V
Range 14.2 V**

- Wafer Maps demonstrate significant wafer surface charging associated with DI rinse step

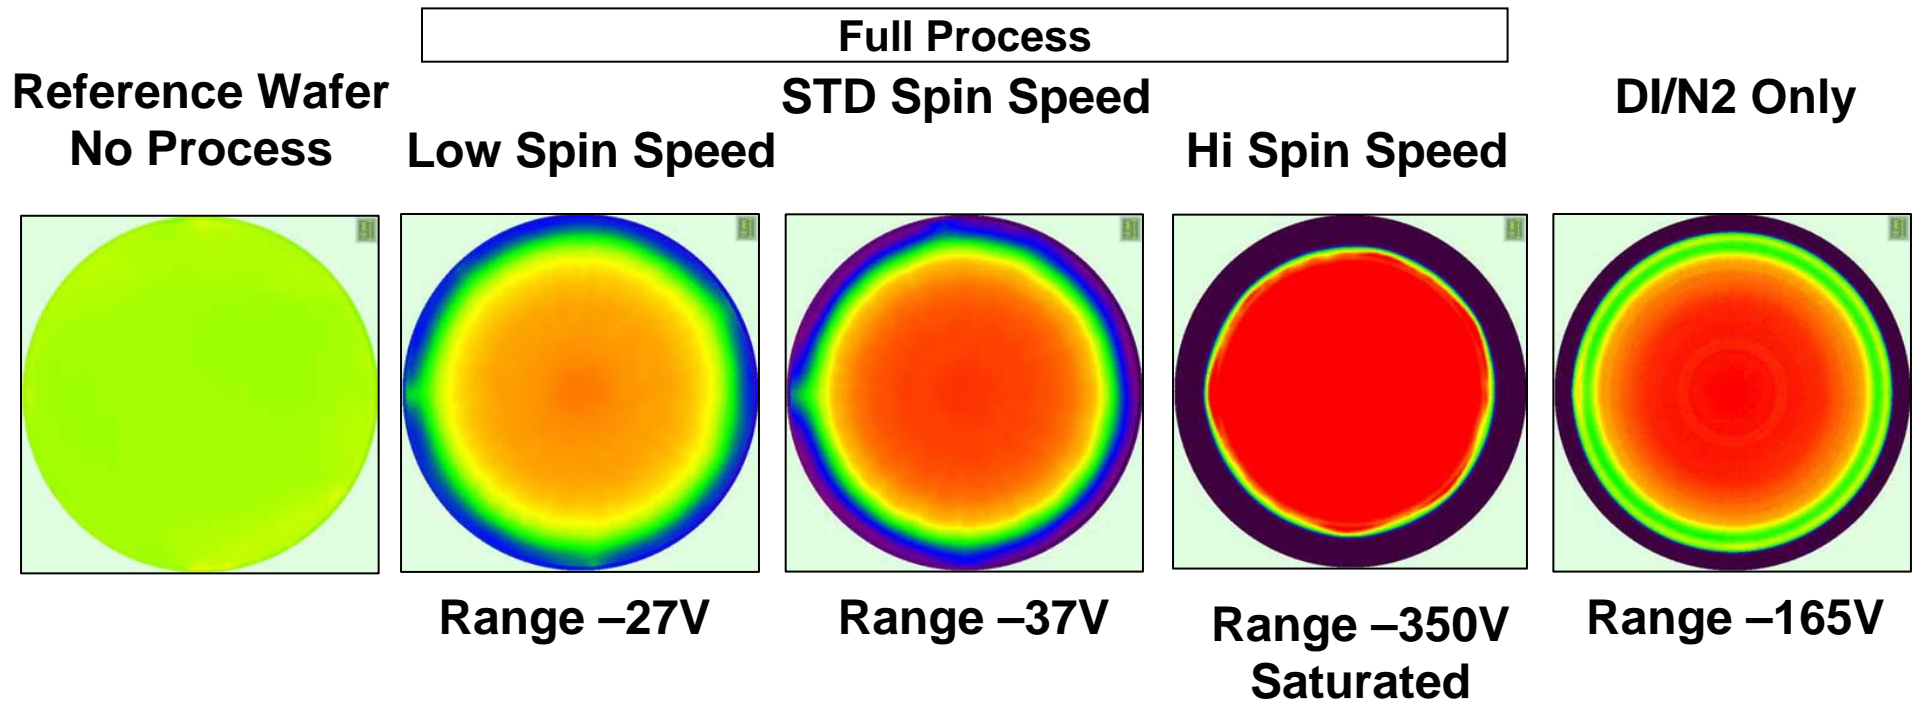
Impact of Spin Speed on Surface Charging

- Wafer Surface charge substantially impacted by spin speed
- Suggests charging mechanism is due to friction between DI Rinse water and wafer surface

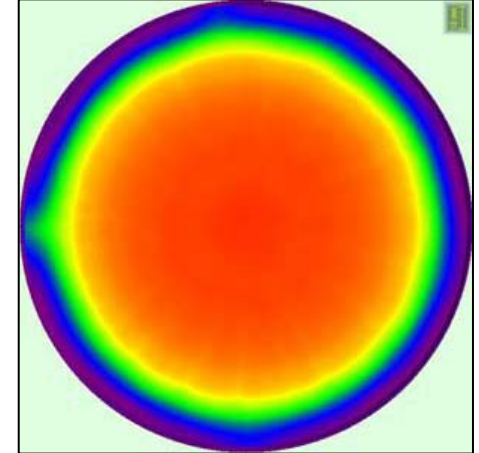
Full Process
DI rinse w/o CO2

Range ~37.0V

- Addition of CO2 to DI rinse Water (30k Ohm) significantly reduces surface charging phenomenon
- Is BEOL/Product integration compatible with use of DICO2?

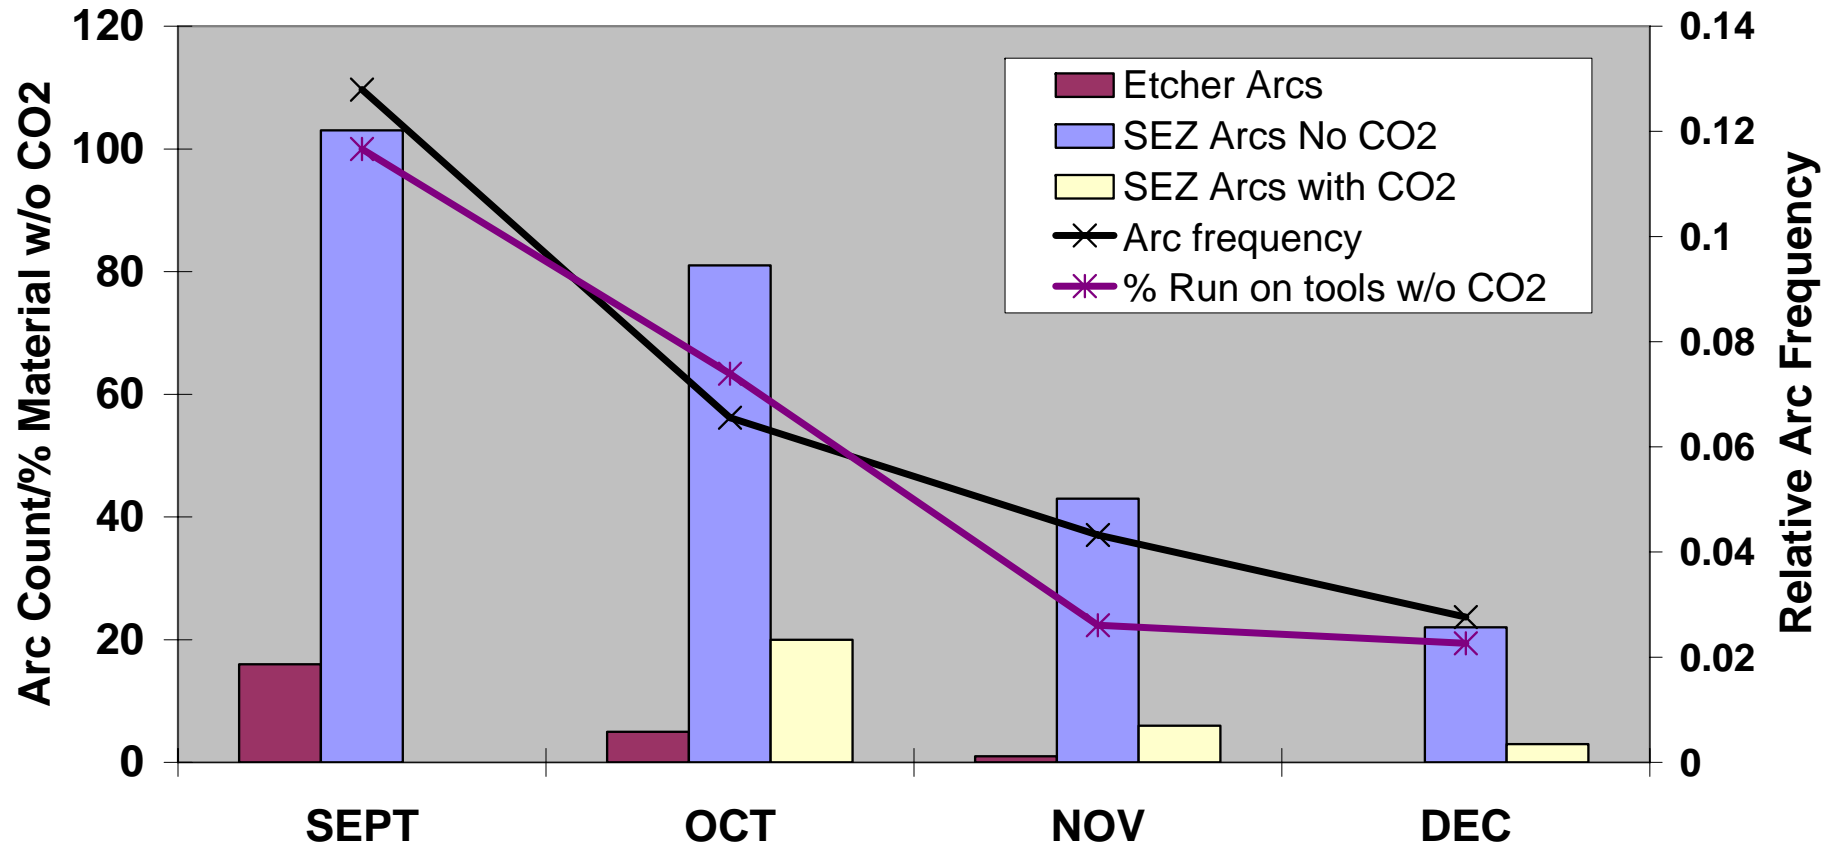
DICO2 Impact on Detected Arcs

Arc defect frequency falls as % of wafers run with CO2 increases

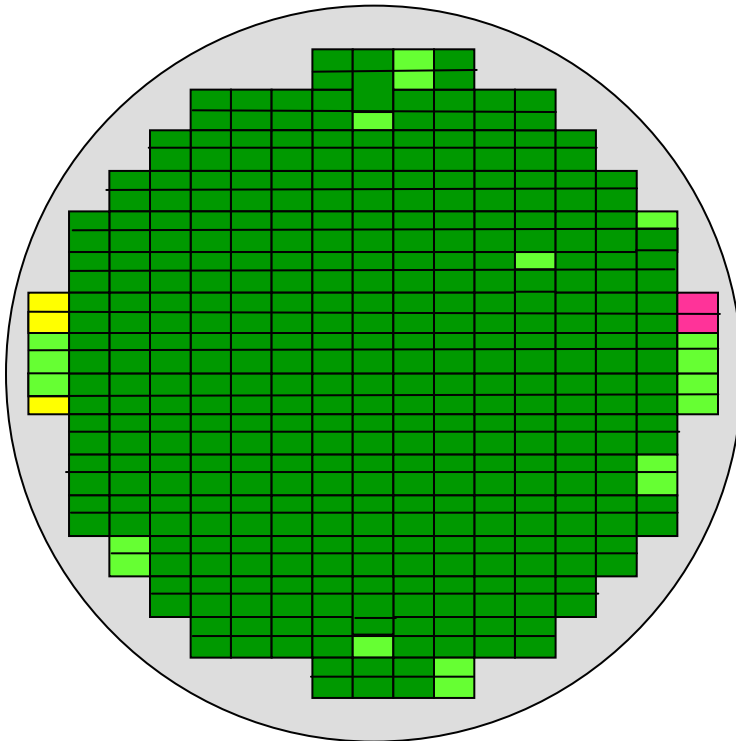
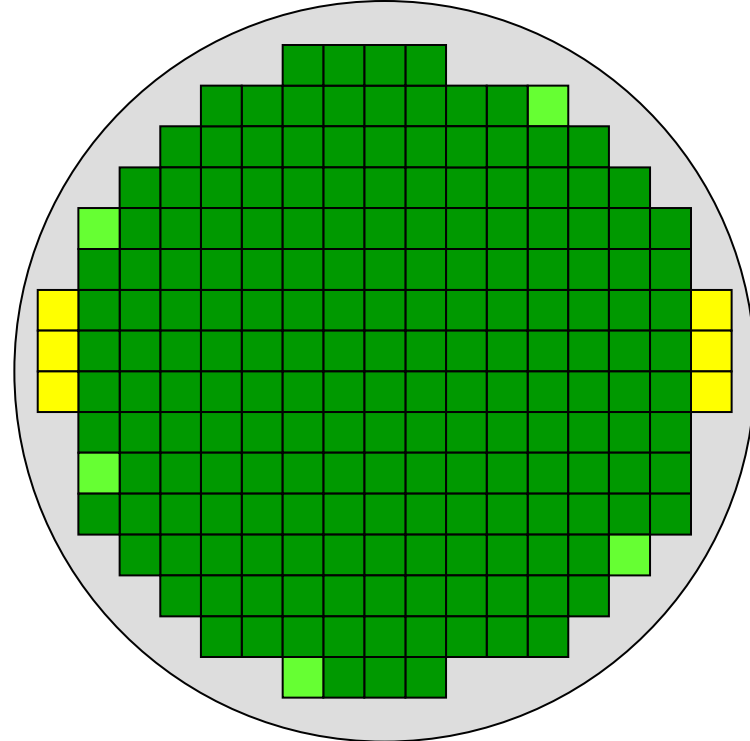
- **Stacked wafer maps (~120 wafers) center donut region with reduced yield has been eliminated on wafers run with DICO2**

- **Single wafer Spin Processing with high resistivity DI rinse steps can lead to arcing with significant impact on yield**
- **Reducing DI resistivity by addition of CO2 reduced arc formation and eliminated donut pattern of reduced yield**
- **Addition of CO2 has no known negative impact on any product or test wafer substrates**
- **Collaborative approach between Spansion, Qcept, and SEZ allowed comparatively rapid learning and implementation of a solution to improve yield**
