VOC & Metallic Contaminant Control For SOI Process Monitoring

Roland Brun¹, Cécile Moulin¹, Christophe Girard¹

¹Soitec, Parc technologique des Fontaines, Bernin, 38926 CROLLES Cedex France

²Qcept Technologies, 75 Fifth Street NW, Suite 740 Atlanta, GA 30308 USA

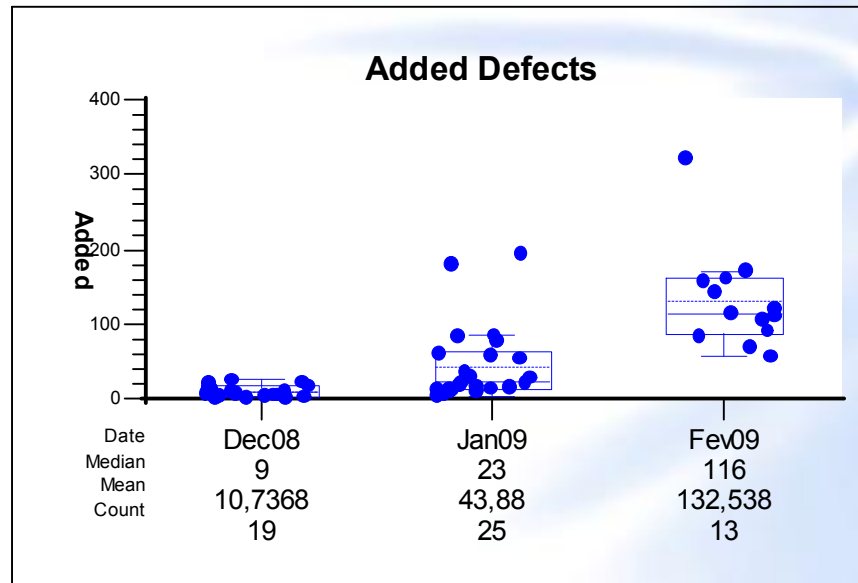
Problem Description - Increasing Particle Defects

- 50 nm particle levels were increasing after a particular in-line cleaning step

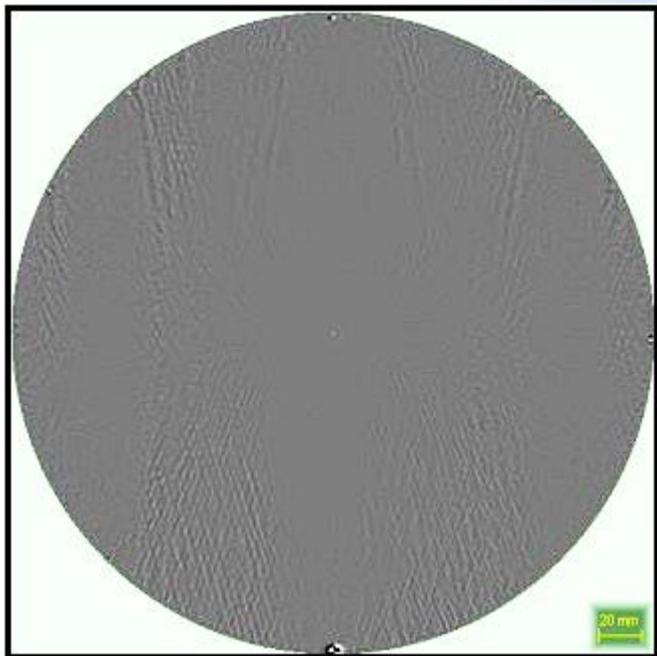
Qcept map after clean :

QCEPT pattern matches with particle defectivity seen at 50nm !!

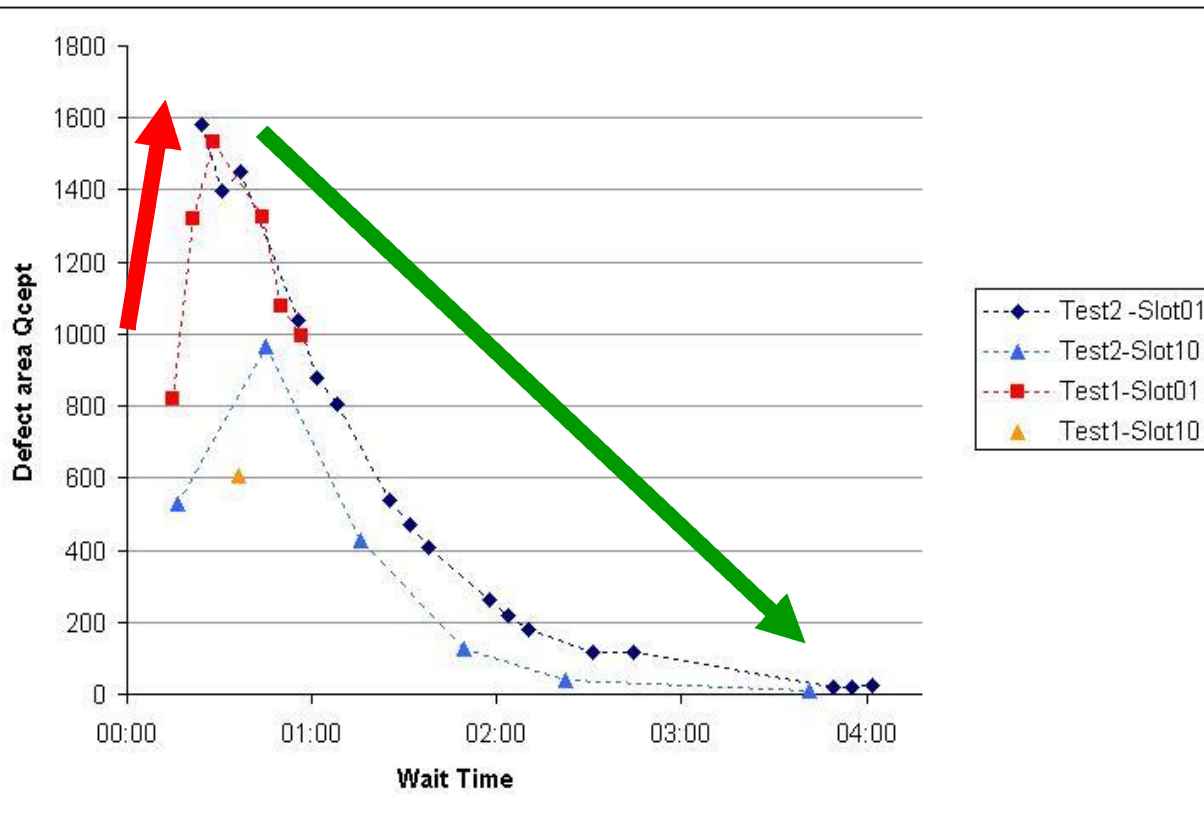
Phase 1 : water layer is uniform; during evaporating water film becomes fragmented; increasing QCEPT defectivity.

Phase 2 : water continues to evaporate until disappearing, returning QCEPT defectivity near 0.

- Defective Area increases at first and then decreases with time
- Hypothesis: The ChemetriQ is detecting water on the wafer surface

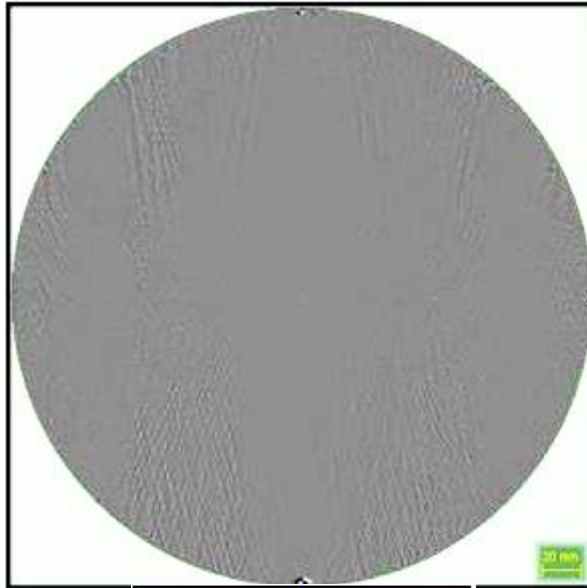
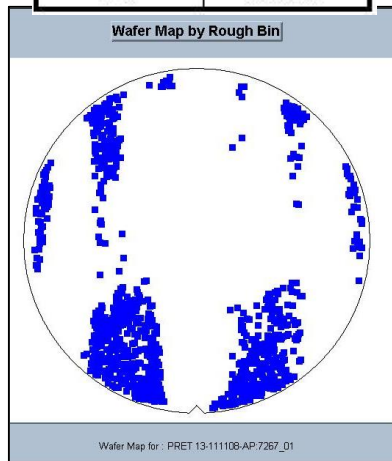
Time \approx 1 hour

Defect count	Defect area
863	2179.8

Pattern intensity seen by QCEPT immediately after cleaning increases during the 1st hour then decreases to zero after \sim 4hours

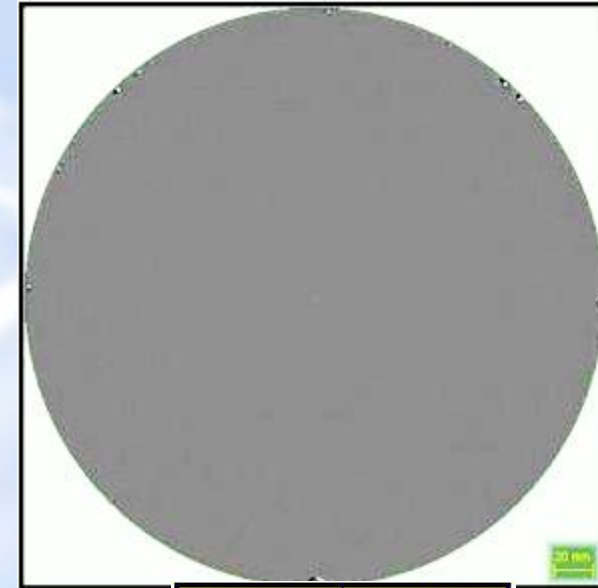
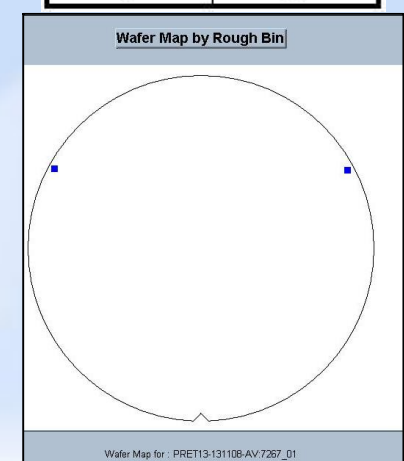
Time \approx 4 hour

Defect count	Defect area
2	4.7

The corresponding defect maps show the decrease in defect counts after 4 hours

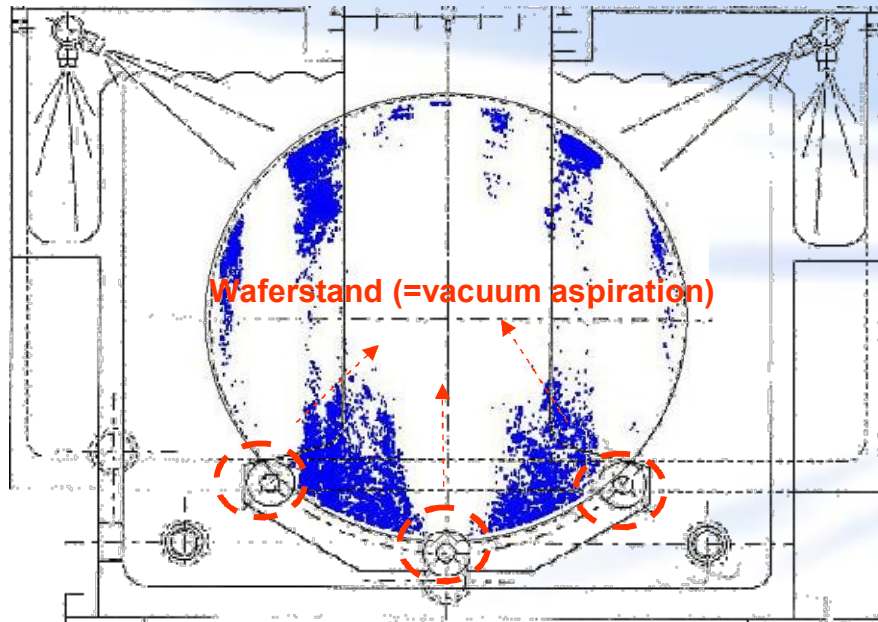
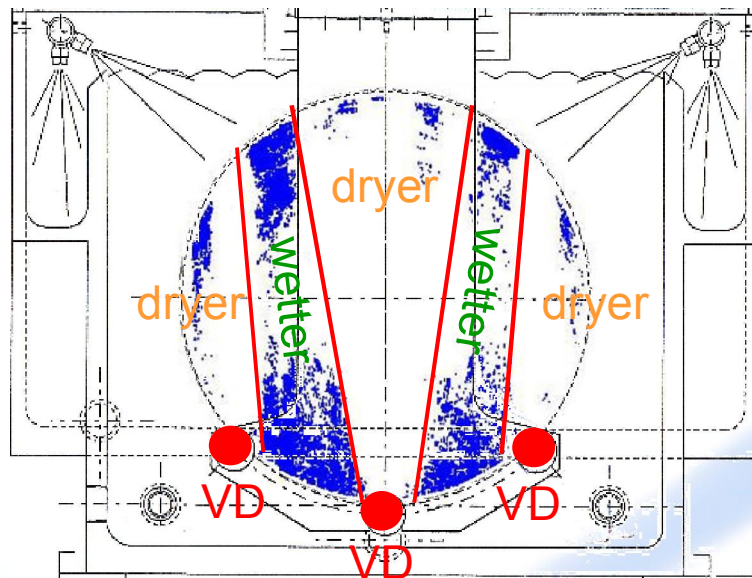
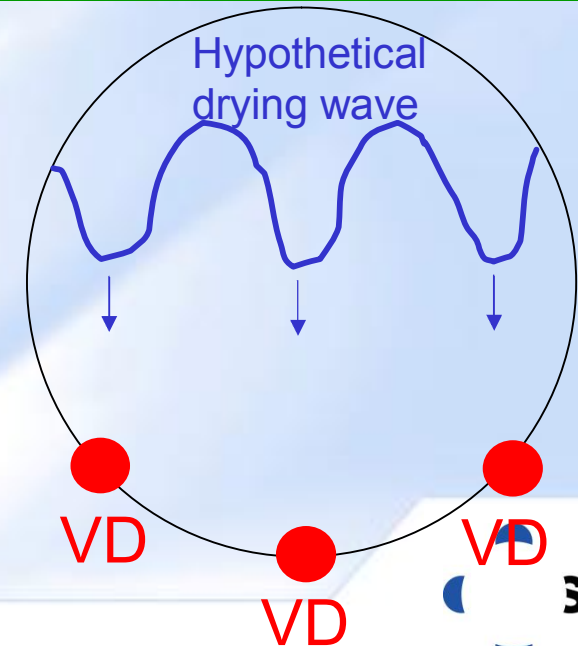
Link with cleaning tool :

- QCEPT pattern seems to be correlated with waferstand & VD (vacuum dry) position
- Area where the drying is faster allows particles to deposit on the wafer
- Corrective action has begun

VD = Vacuum Dry

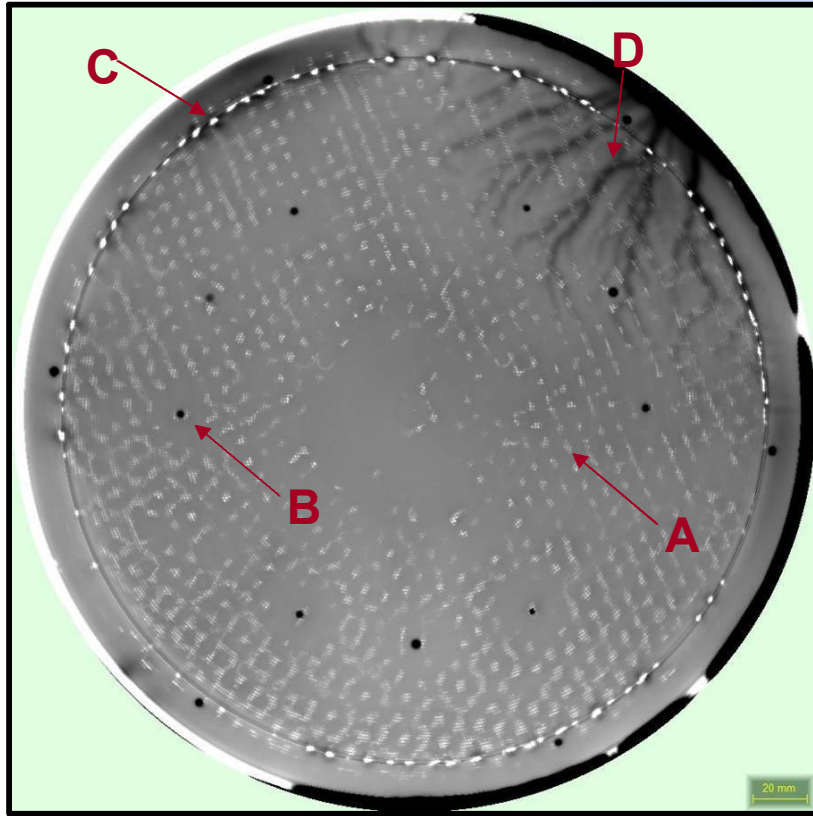
VPD-ICPMS showed Al contamination at $1.2E10$ atoms/cm²

- A particular metrology tool was causing backside Aluminum contamination
- The chuck was suspected and was cleaned many times and the vendor was designing a lower contact chuck
- The image at the left is a ChemetriQ integrated image from a wafer that was placed on the chuck of the metrology tool
- There are 4 distinct regions:
 - Chuck signature (A)
 - Lifter pin signature (B)
 - Electrostatic Ring signature (C)
 - “Dendrite” region (D)

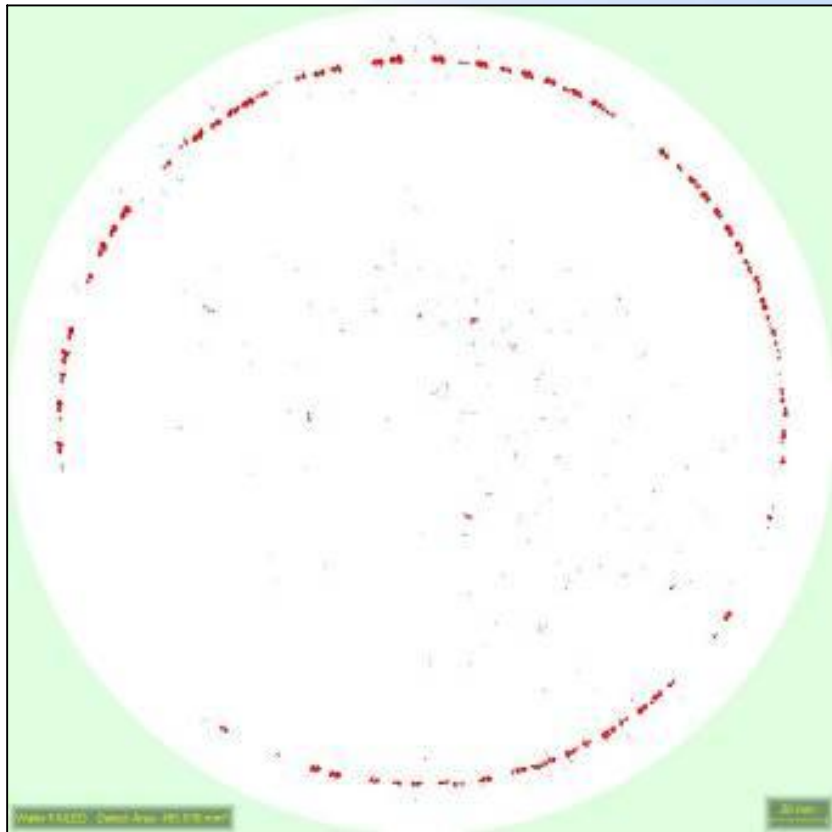
- Positive work function (+WF) defects are generally metallic and negative work function (-WF) defects are generally organic
- So the integrated image was thresholded for +WF defects only
- The resultant defect map showed that the strongest defects were in a ring near the edge of the wafer and not in the center of the wafer from the chuck
- This signature led us to perform TOF-SIMS at the ring signature

The defect map showed that the outer ring was likely the primary source of contamination and not the chuck signature

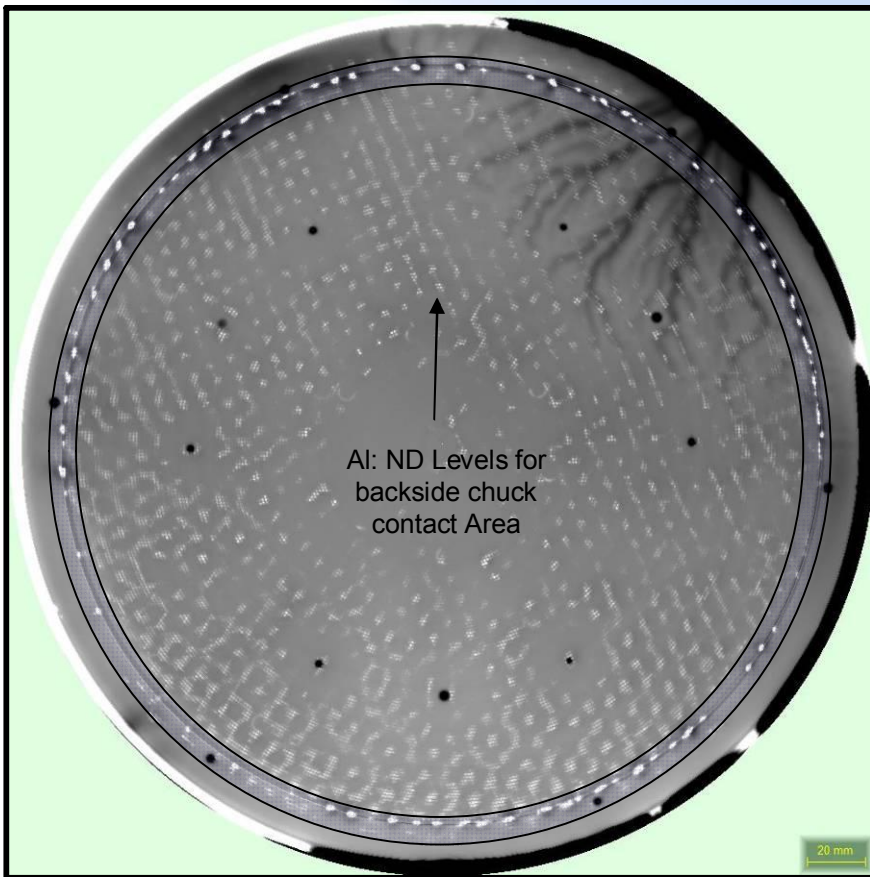
Al: $\sim 5E11$ atoms/cm²

$1.18E10$ atoms/cm²

$1.20E10$ atoms/cm²

- The outer ring was analyzed using a TOF-SIMS to identify the element
- Interior reference points of the chuck touch points were also selected with no detectable levels of Al ($<1E8$)
- The outer ring analysis showed an average level of Al contamination at the $5E11$ range, with a maximum reading of $6E12$ atoms/cm²
- The outer ring concentration, when adjusted for area, matched the level of Al from the VPD ICPMS testing
- The proper spatial information provided by the ChemetriQ analysis allowed us to focus on the true source of the contamination

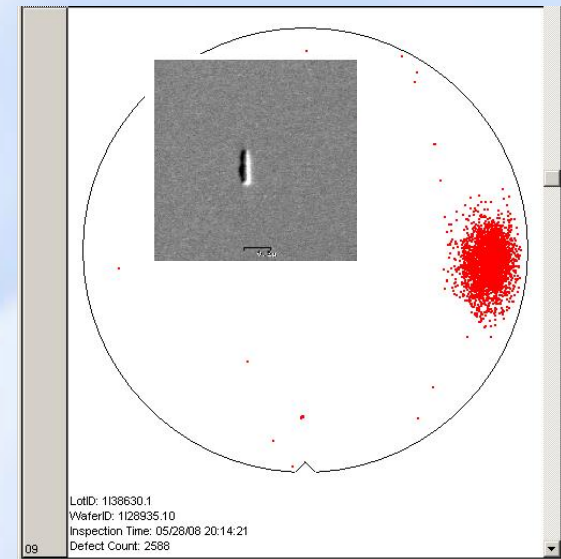
- **Some SOI wafers were experiencing a yield killing defect at final inspection**
- **This defect was a group of small gouges at the surface located predominately near the 3 o'clock position on the wafer**
- **Traditional inspection techniques could find this defect only at final inspection**
- **The root cause was isolated to a metrology tool that inspected at a step prior to the oxidation step**
- **An inspection was needed to detect this defect at the current process step**

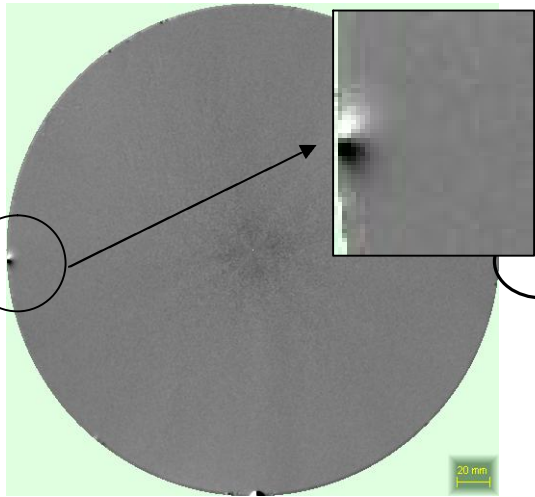
Bad Wafer

- The circled defect on the left is a metallic defect at the very near edge of the wafer
- This matches a touch point from the metrology tool
- This defect at the 9 o'clock position on the SOI donor wafer is the cause of the yield killing defect at 3 o'clock on the final SOI wafer. The donor wafer is flipped and bonded to the base wafer
- A ChemetriQ inspection is now in place as a tool monitor of this metrology tool
