VOC & Metallic Contaminant Control For SOI Process Monitoring

Roland Brun¹, Cécile Moulin¹, Christophe Girard¹

¹Soitec, Parc technologique des Fontaines, Bernin, 38926 CROLLES Cedex France

²Qcept Technologies, 75 Fifth Street NW, Suite 740 Atlanta, GA 30308 USA

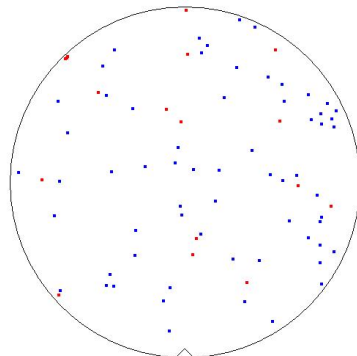
Dec 08
added

- 50 nm particle levels were increasing after a particular in-line cleaning step

QCEPT pattern matches with particle defectivity seen at 50nm !!
